CAPITAL IMPROVEMENT PLAN FOR THE

**Village of Barker
Capital Improvement Plan
September 2011**

**Village of Barker
Capital Improvement Plan
October 2005
Updated September 8, 2011**

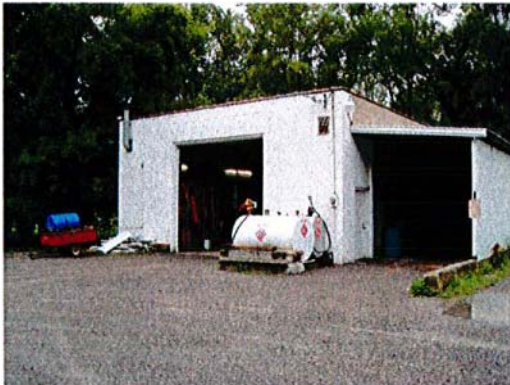
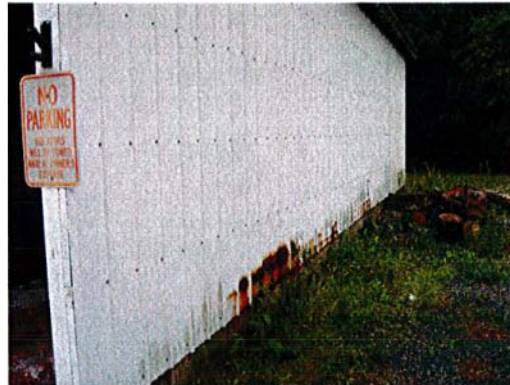
Salt storage facility in need of rehabilitation

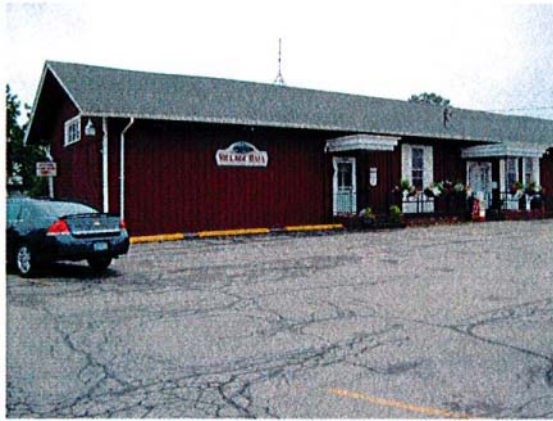
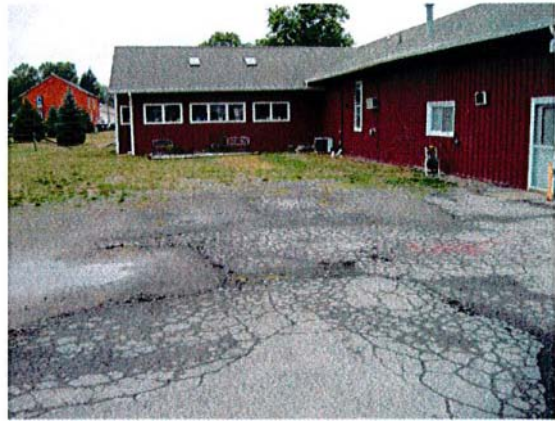
Village Hall Building & Rear side view showing need for parking improvements.

- The existing electrical service to Village Hall is 100 amps. Although considered adequate at this time, some consideration should be given to increasing the service capacity, if necessary.
- The pavement in the parking area in front of the building is in fair to poor condition. This area should be top-coated and striped to prevent further deterioration.
- Consideration should be given to paving the approximate 50' by 60' area directly behind the Village Hall portion of the building.
- Presently, the Village Hall does not have stand-by power for activation during a storm-related or other emergency. Consideration should be given installing a permanent emergency generator so that normal Village Office, Barker Police Department, and Barker Free Library operations can be conducted during an extended power outage.

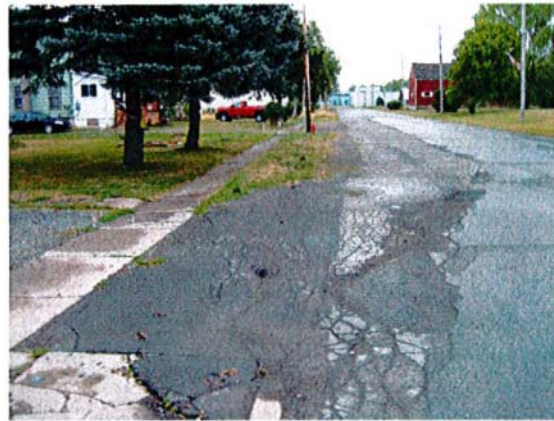
North side of Main Street near Pallister showing broken, uneven pavement sections, lack of curbing and insufficient drainage.

Main Street – Due to its high visibility, high vehicle and pedestrian use, all in conjunction with some easily observed pavement and surface deficiencies; Main Street remains one of the Village's top priorities for improvement. Recommended improvements from the 2005 CIP, and further supported by 2011 observations include: milling and resurfacing of pavement between Quaker Road and East Avenue; new storm sewer piping between Quaker Road and East Avenue; new concrete curbing from Pallister to East Avenues; and new 4' concrete sidewalks along the south side of Main Street in front of Village Park and between Pallister and East Avenues.

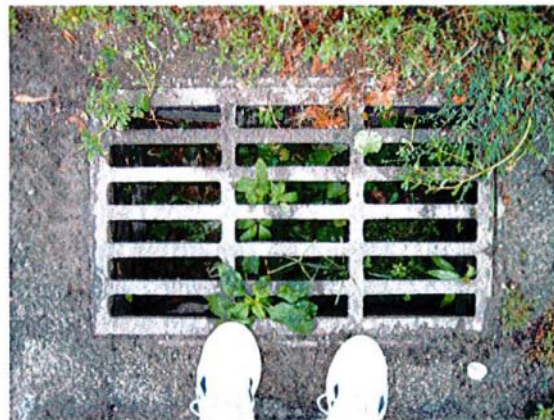
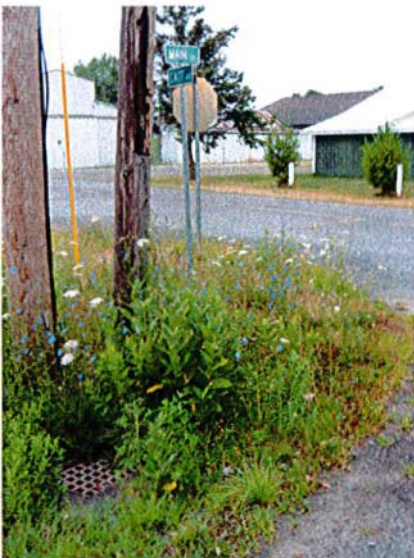
Main Street – Approximately one half of Main Street appears to have a storm sewer system. Smoke testing indicated that several sections have, or discharge to, crushed, broken, or plugged storm sewers. During heavy rainfall events, the area of Main Street at the intersection of East Avenue routinely fills with several inches of water. No curbs or gutters are present on Main Street between East and Pallister Avenues. Between Pallister Avenue and Quaker Road there are, however, granite curbs with 4" reveal on the south and concrete curbs with approximately 2" reveal on the north sides of Main Street.

Broken catch basins along Main Street in front of Village Park, HSBC Bank and corner of East Avenue serving for ineffective drainage and difficulty of maintenance.

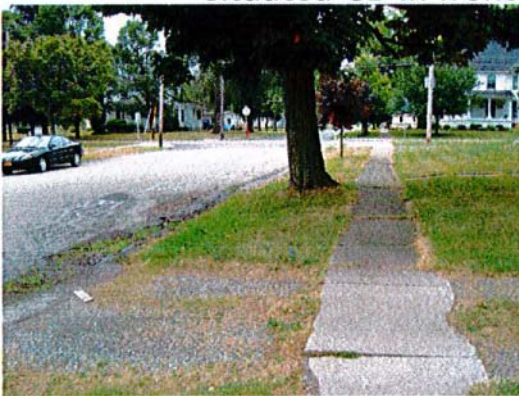
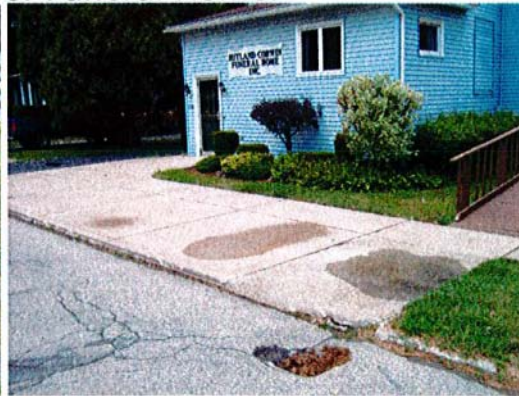
Pallister Avenue – Similar problems that were found on Church Street and East Avenue were found to exist on Pallister Avenue. Only slightly less than half of this street appears to have a storm sewer system. In one area (House Nos. 1701-1713), however, catch basins are located on both sides of the street. The point(s) of discharge from the Pallister Avenue storm sewers is, however, unknown. As was found with Church Street and East Avenue, major portions of the Pallister Avenue storm sewers have, or discharge to, crushed, broken, or plugged storm sewers. Some curbing sections exist between Coleman Road and Church Street; however, no reveal is left to this curbing. Also, no other positive measures such as roadside swales, gutters, or defined shoulders exist to adequately address road drainage. In a number of areas edges of pavement have broken away and shoulder material has washed into lawn areas.

Pallister Avenue between Church and Coleman / Poorly situated CB in front of Funeral Home.

Pallister Avenue – In 2005 Pallister Avenue was also determined to have significant need for improvements to pavement roadway facilities. Based on the identification of these needs the Village performed repaving of the street from Coleman Road to the southern dead end. Although these surface improvements will suffice over the short term, it is still recommended that the following items remain within the capital improvement recommendations: milling and

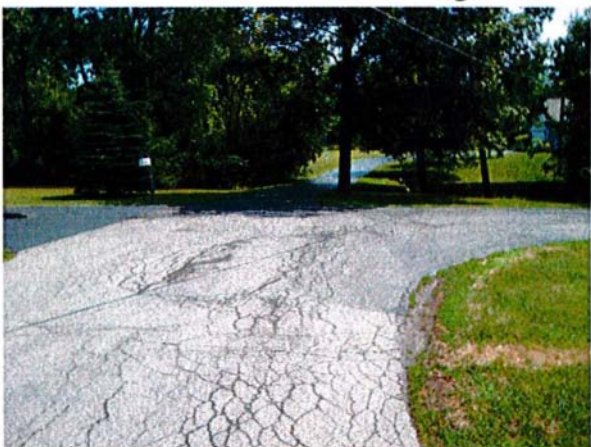
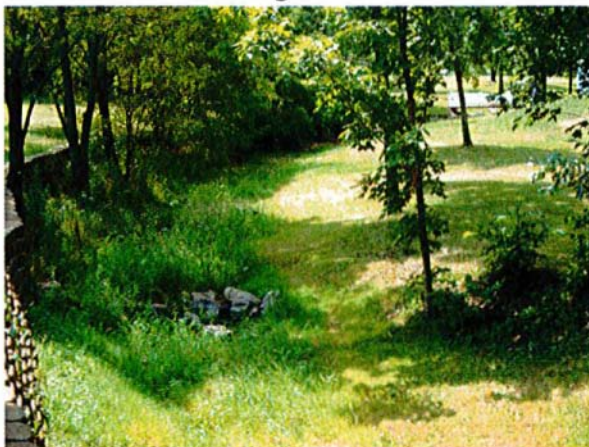
East Avenue viewing northerly between High and Coleman.

East Avenue was found to have low to moderate traffic volume, good to fair pavement conditions but no defined shoulders between Church and High Streets, and drainage in need of significant improvement throughout the entire length. Pavement surfaces between Church Street and Coleman Road were significantly improved through a Niagara County – Village paving improvement project in 2010. However, it is recommended that those sections between Main and Church Streets, and Coleman Road and High Street being scheduled for milling and resurfacing.

East Avenue – East Avenue exhibits most of the same problems as Church Street. Although slightly over half of East Avenue appears to have storm sewers, smoke testing revealed a major portion has crushed, broken or plugged piping. Also, almost all of the catch basins are on the west side of the road. Additionally, no positive measures such as roadside swales, gutters, curbing or defined shoulders exist to adequately address road drainage. In a number of areas edges of pavement have broken away and shoulder material has washed into lawn areas.

East Avenue – In the 2005 CIP Report, most of the entire length of East Avenue was determined to be in need of improvement. Addressing this concern as a priority, the Village, in partnership with the Niagara County Highway Department, provided new paving in 2010 for the section between Church Street and Coleman Road. To supplement these improvements, the following additional items are recommended: new concrete curbing from Main Street to High Street; new storm sewer piping from Main Street to High Street; milling and resurfacing of pavement from Main Street to Church Street and from Coleman Road to High Street; new 4' concrete sidewalks on both sides of East Avenue between Main and Church Streets, on the west side of East Avenue from where the sidewalk presently ends at 1712 East Avenue to Coleman Road, and on the east side of East Avenue between Coleman Road and High Street. All required water system improvements for East Avenue were completed as part of the 2010 Phase I Water System Improvements.

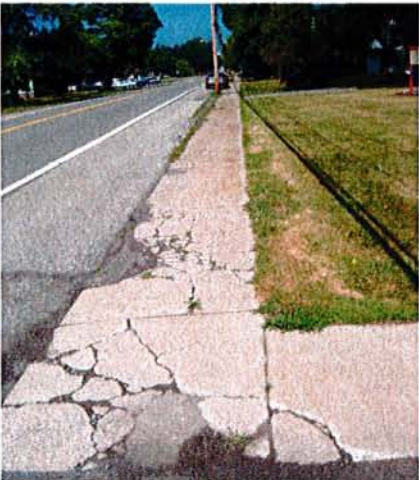
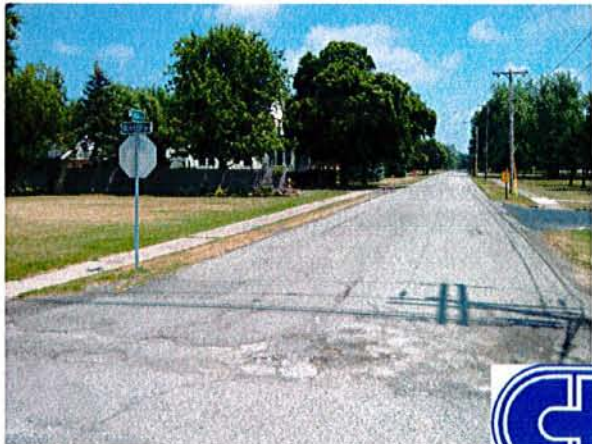
Badly cracked sidewalk on Quaker near High St / High St viewing east from Quaker.

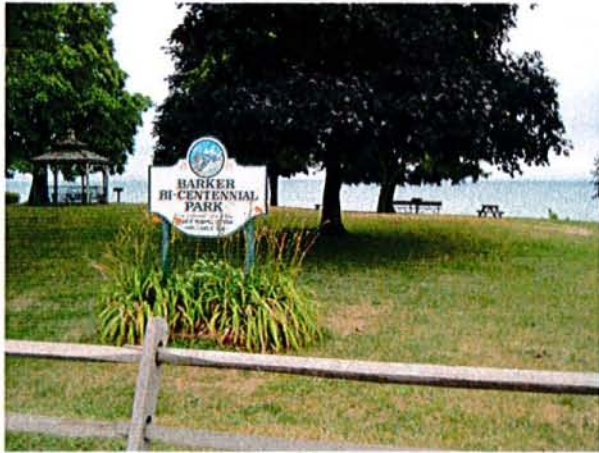
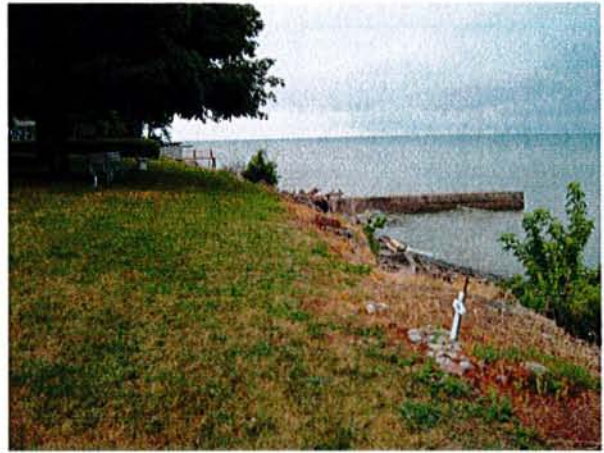
Barker Bi-Centennial Park

Beach and embankment area in need of evaluation and likely design of shoreline erosion protection features.

Bicentennial Park – Shoreline erosion protection should be further evaluated, and designed and constructed if necessary. Also, several “sink holes” should be repaired.
